Piper Alpha, 1988: lessons in work control, containment and emergency readiness

A reliability and asset management reading of the case, with five practical checks for operators

Published by AFDARA & Co. · Version 1.3 · 22 November 2026 · linkedin.com/company/afdara-co

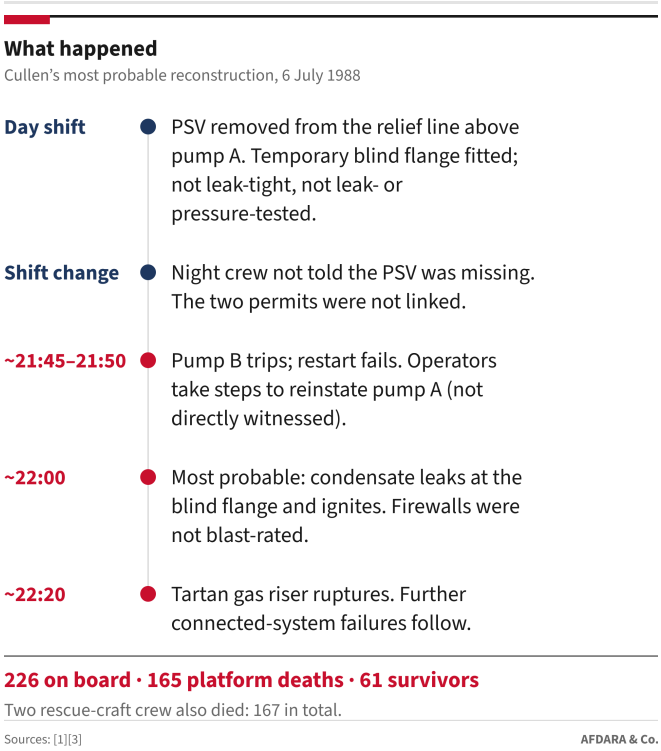
On the day shift, the pressure safety valve (PSV) for condensate pump A was removed. A blind flange was fitted at its location on the relief line, above and away from the pump. The temporary blank-flange assembly was not leak-tight; it was not leak- or pressure-tested [6]. Some secondary accounts describe it as loosely installed [9]; Cullen's formulation is that the assembly was not leak-tight, and its exact tightening condition is not established [1]. The pump and valve work sat under separate permits

that were not linked, and the night crew did not know the PSV was missing [1].

At about 21:45–21:50, pump B tripped and restart attempts were unsuccessful. Operators then took steps to reinstate pump A. Cullen inferred that condensate was admitted to the system, but the decisive action was not directly witnessed. On a balance of probabilities, the blind-flange assembly was the leak source [1][3].

Figure 1. A simplified rendering of Cullen's most probable reconstruction, not a minute-by-minute log. AFDARA diagram, not an official inquiry figure [1][3][6].

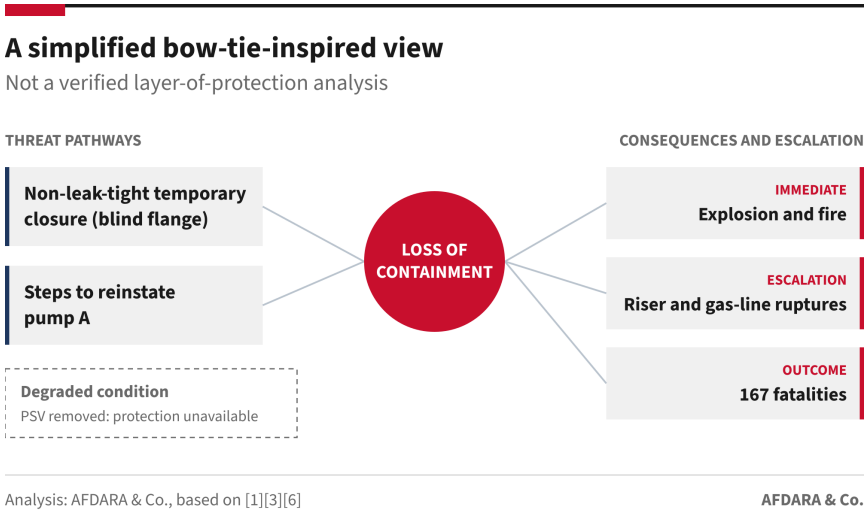
Figure 2. A qualitative cause–consequence sketch: prevention and mitigation controls are listed in this caption, not drawn as barrier nodes. It is a communication model, not a safety-case demonstration, LOPA, QRA, or evidence that the listed barriers were independent [16][17]. Controls that failed or were unavailable: *prevention* — permit linkage, shift handover, effective physical isolation; *mitigation* — firewalls designed for fire separation, not blast resistance; firewater on manual, then disabled by damage or loss of power; emergency command and escape, shutdown authority on connected platforms [1][3][6][15].

Controls that were not independent. Permit linkage and handover shared work-control weaknesses; the lack of effective physical isolation was a separate deficiency. Escalation followed: the firewalls were designed for fire separation, not blast resistance, and the Tartan riser ruptured at about 22:20 [1][3][6].

Neighbouring platforms. Cullen found the offshore installation managers on Claymore and Tartan ill-prepared for an emergency on a connected installation [1]. An earlier shutdown of oil production on the connected platforms would probably have delayed the Tartan riser rupture; the timing of gas-line depressurisation would not materially have affected the Piper fire, and the outcome of earlier action remains uncertain [1][3].

Firewater was more than one problem. The pumps were on manual because of diving operations, so starting them needed manual intervention [1][9]. The first explosion also put the main power supply and the control room out of action [1][15], and firewater distribution piping in the worst-affected module was badly corroded, with about

half its sprinkler heads found plugged in tests in May 1988 [1][9].

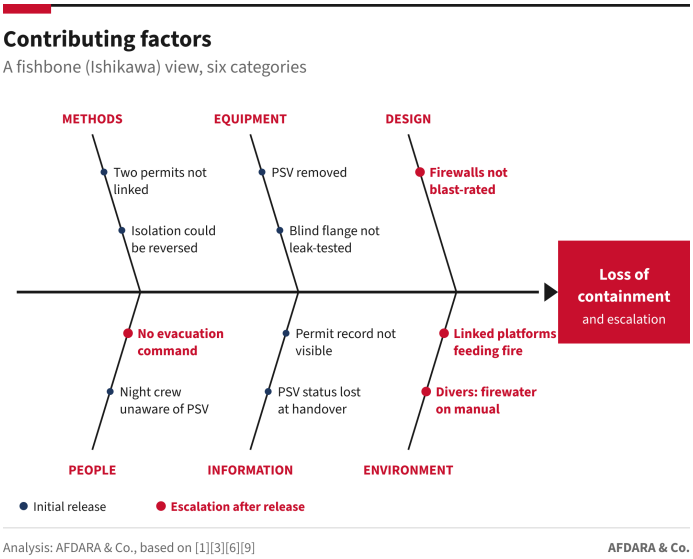
Figure 3. A workshop aid by AFDARA & Co.: a contributing-factor map for structuring discussion. It is a practitioner interpretation, not Cullen's taxonomy or a complete accident model [1][3][6][9].

One selected branch (workshop aid). Following a single chain of "why?": condensate most probably escaped at the temporary closure; the line was pressurised because the crew did not know the PSV was missing; they did not know because the permits were not linked and handover did not pass it on; the pump could be reinstated because isolation could be reversed before the work was complete [1][3]. Real causation had several branches.

Recorded signals. Relevant deficiencies and prior incidents were recorded before the disaster, including concerns about firewater arrangements: a 1983 audit recommended ending the practice of keeping the pumps on manual [9]. Hansard confirms that a report on a 1984 Piper Alpha explosion existed and was to go to the inquiry; its findings are not assessed here [10]. Regulator inspections had found deficiencies [7]. Paté-Cornell traces the technical failures to organisational roots and supports combined technical and organisational risk reduction [5].
